SOIL EROSION SERVICE

Bethany, Missouri.

Name Mr. Paul B. Strickler.

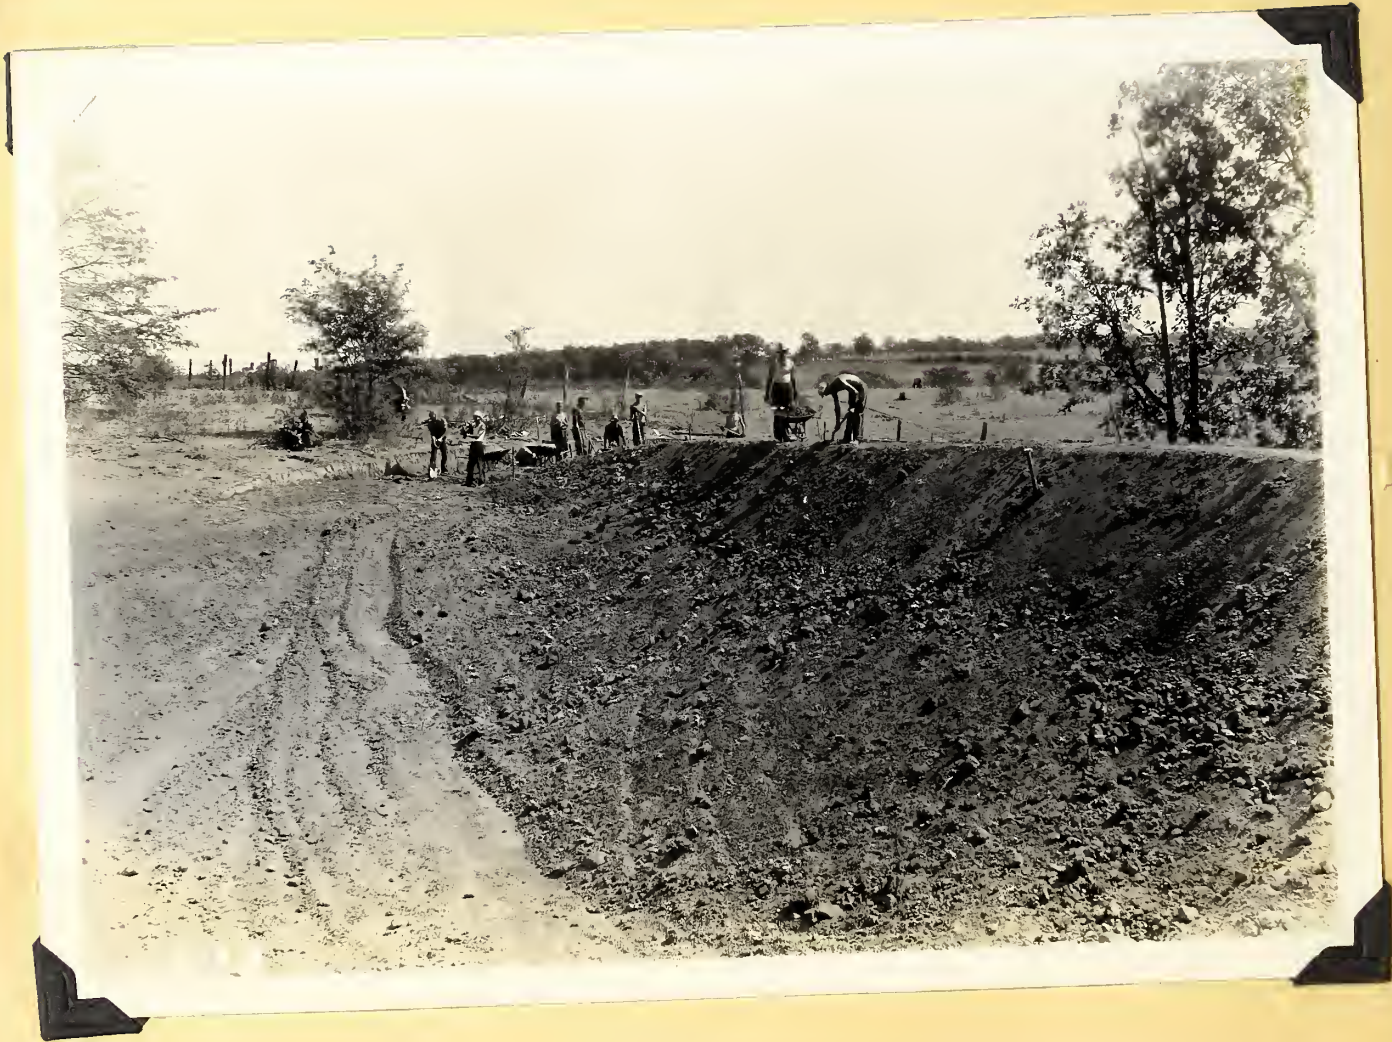
U. C. C. boys making a spillway and building up dam.

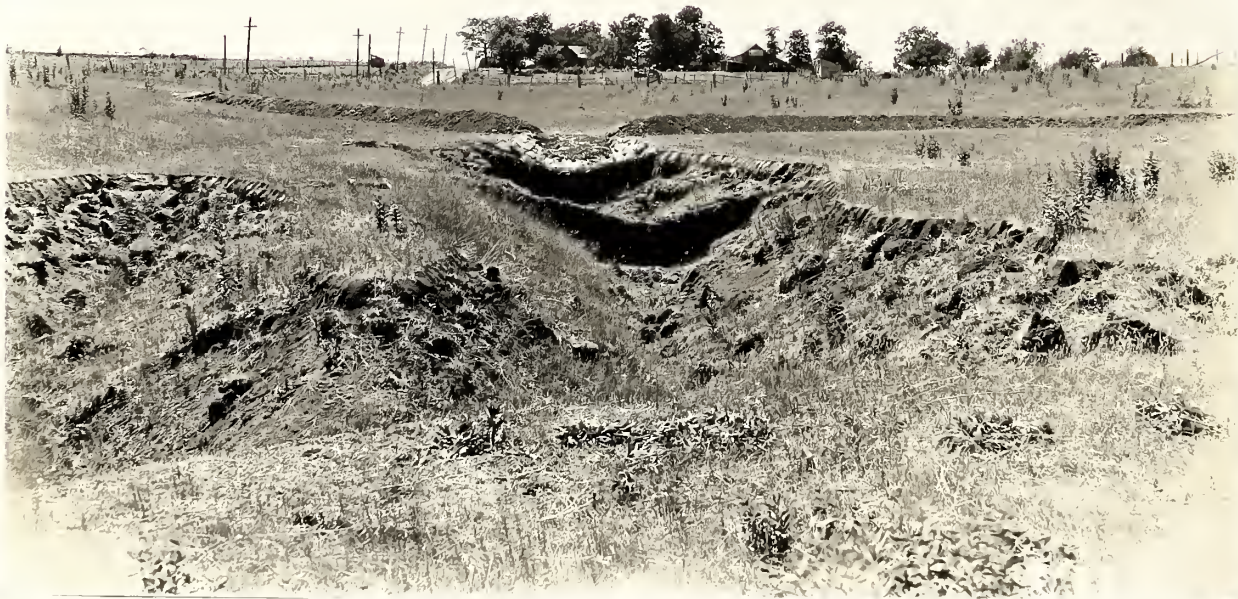
. A serious situation being corrected by diversion ditch and dams.

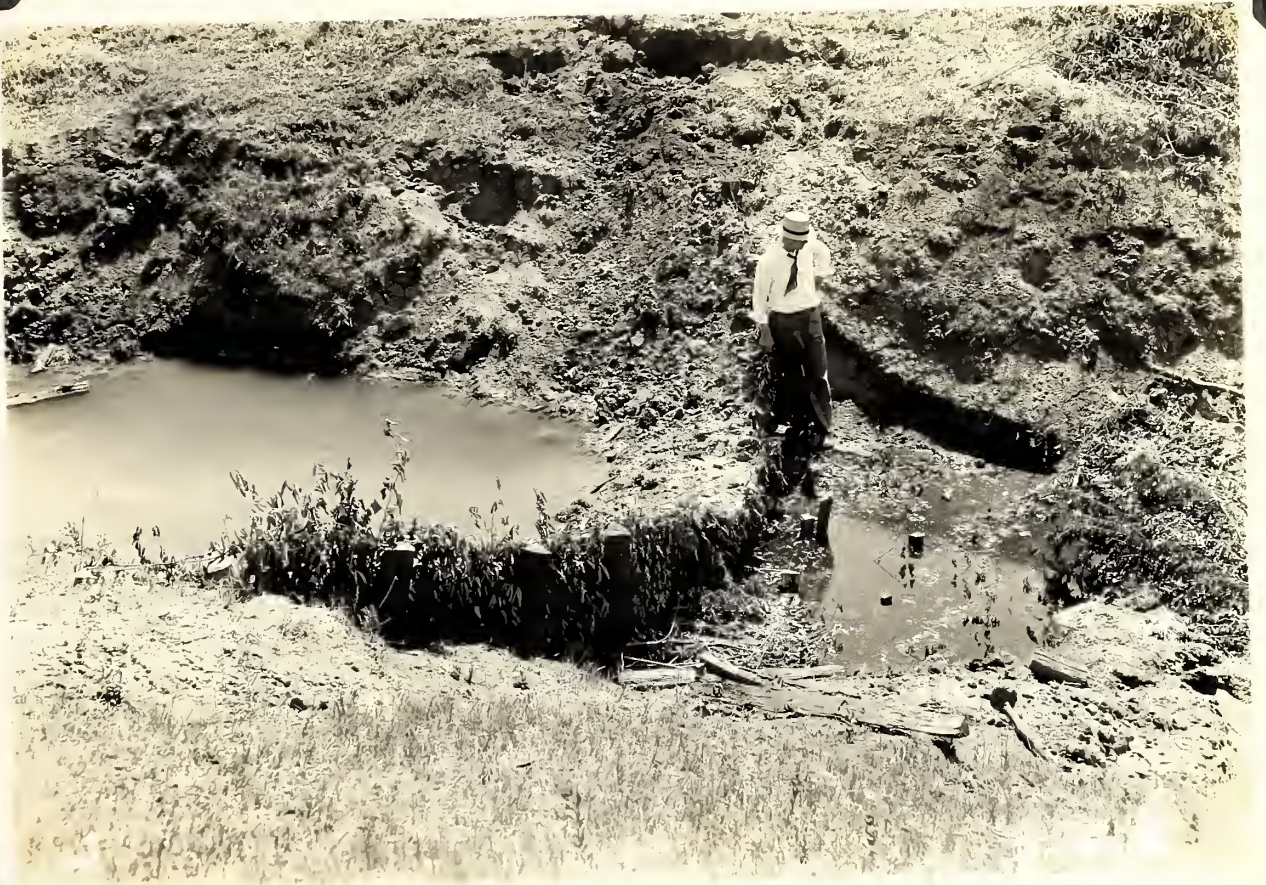
A woven-wire check dam in action.

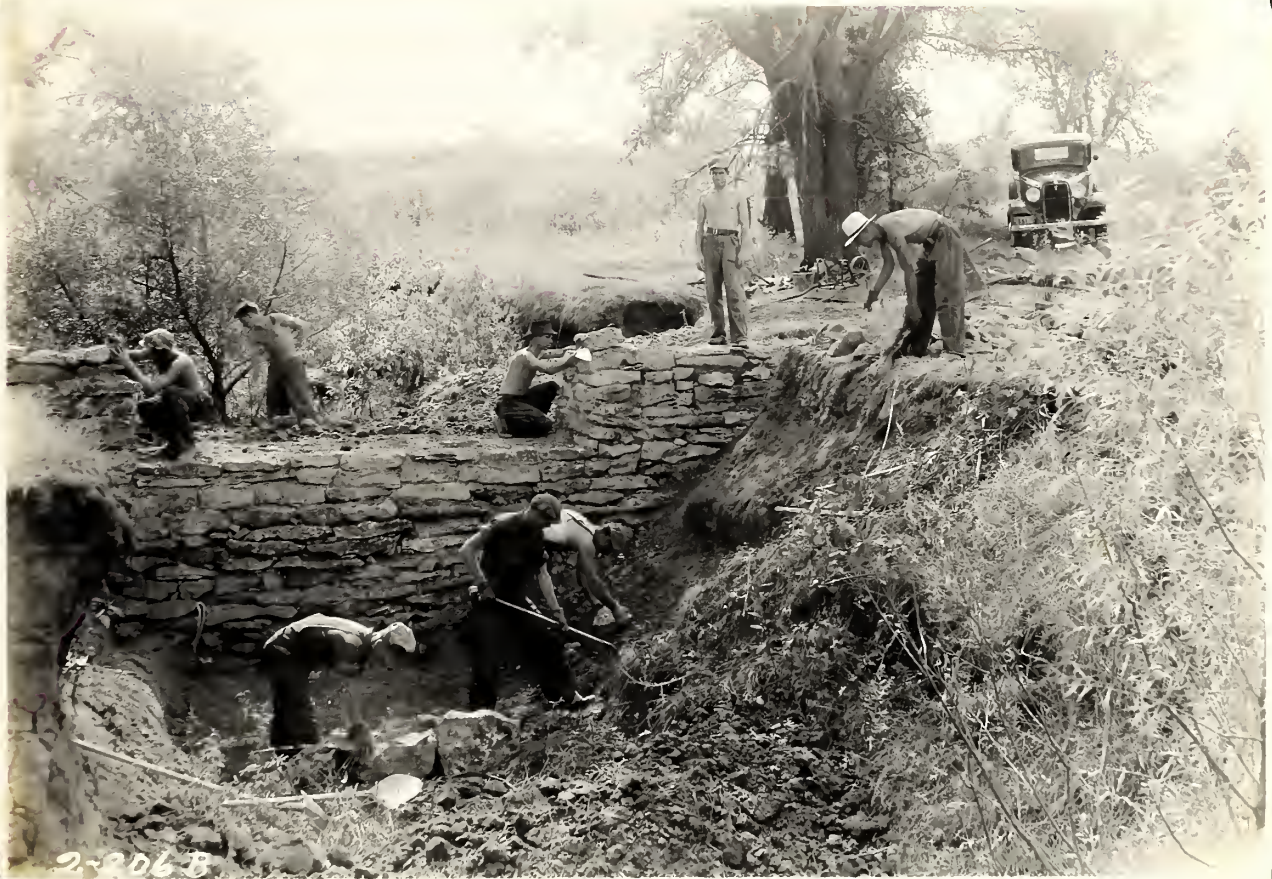
C. C. C. boys constructing rubble masonry  
rock dam.

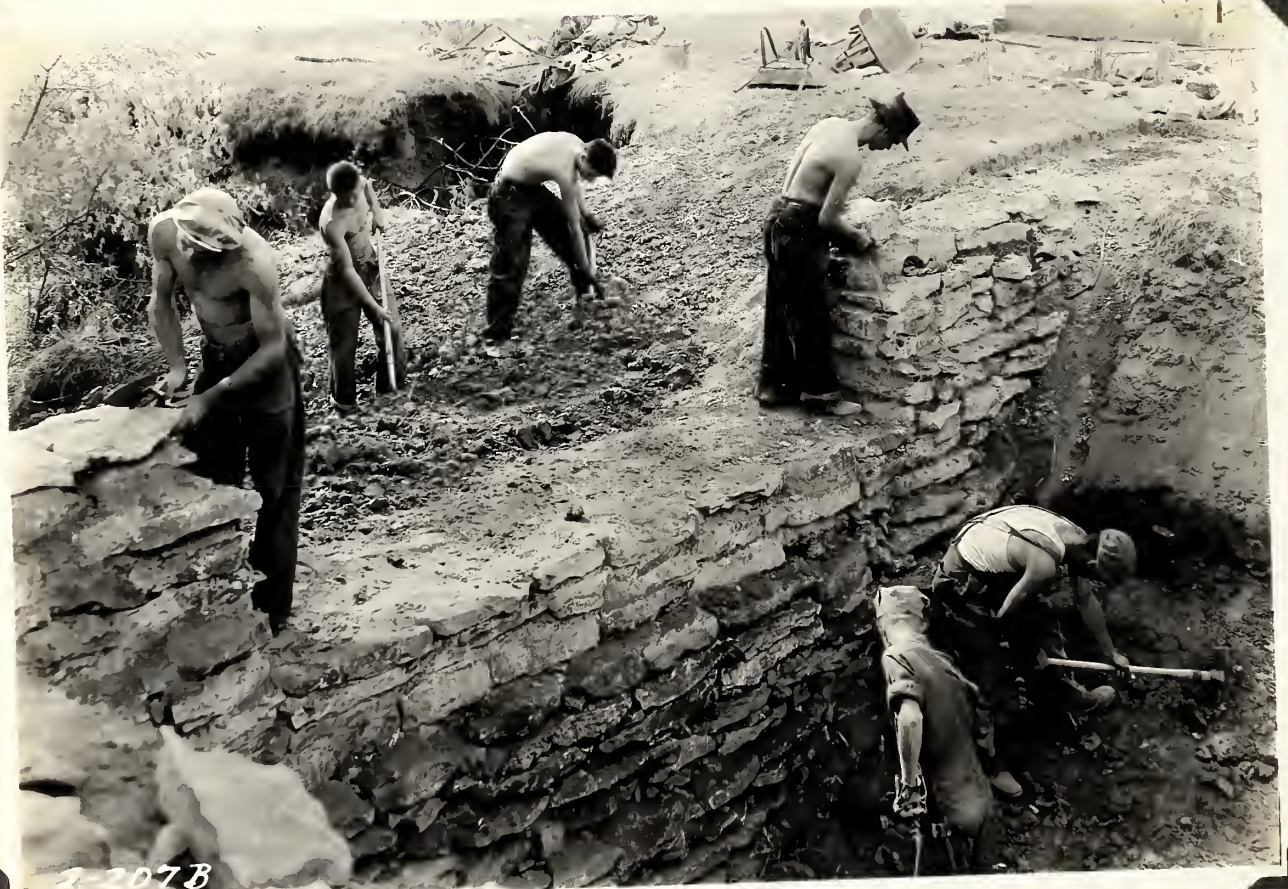
C. C. C. boys completing rubble masonry rock dam.

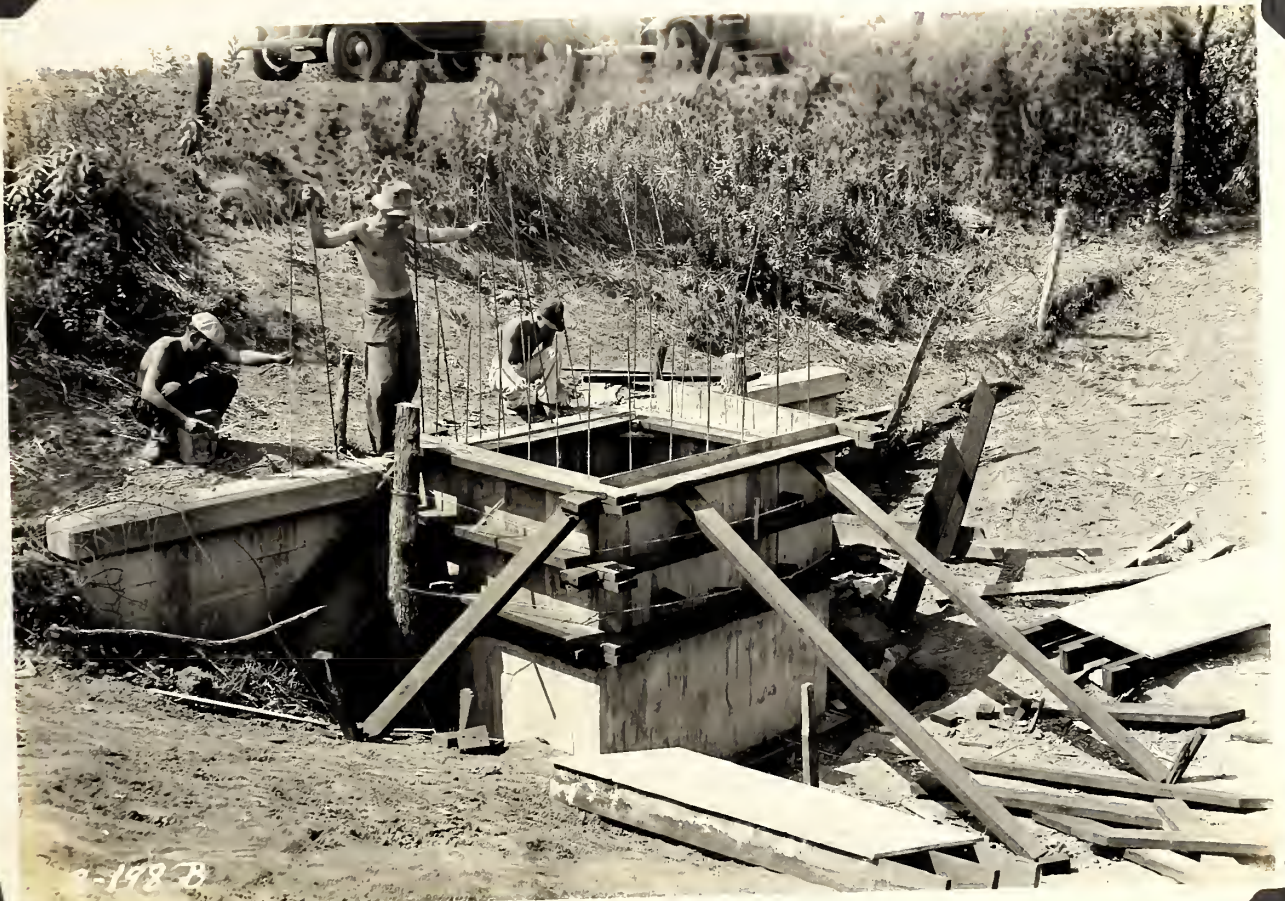
A drop-inlet dam being made out of highway culvert.

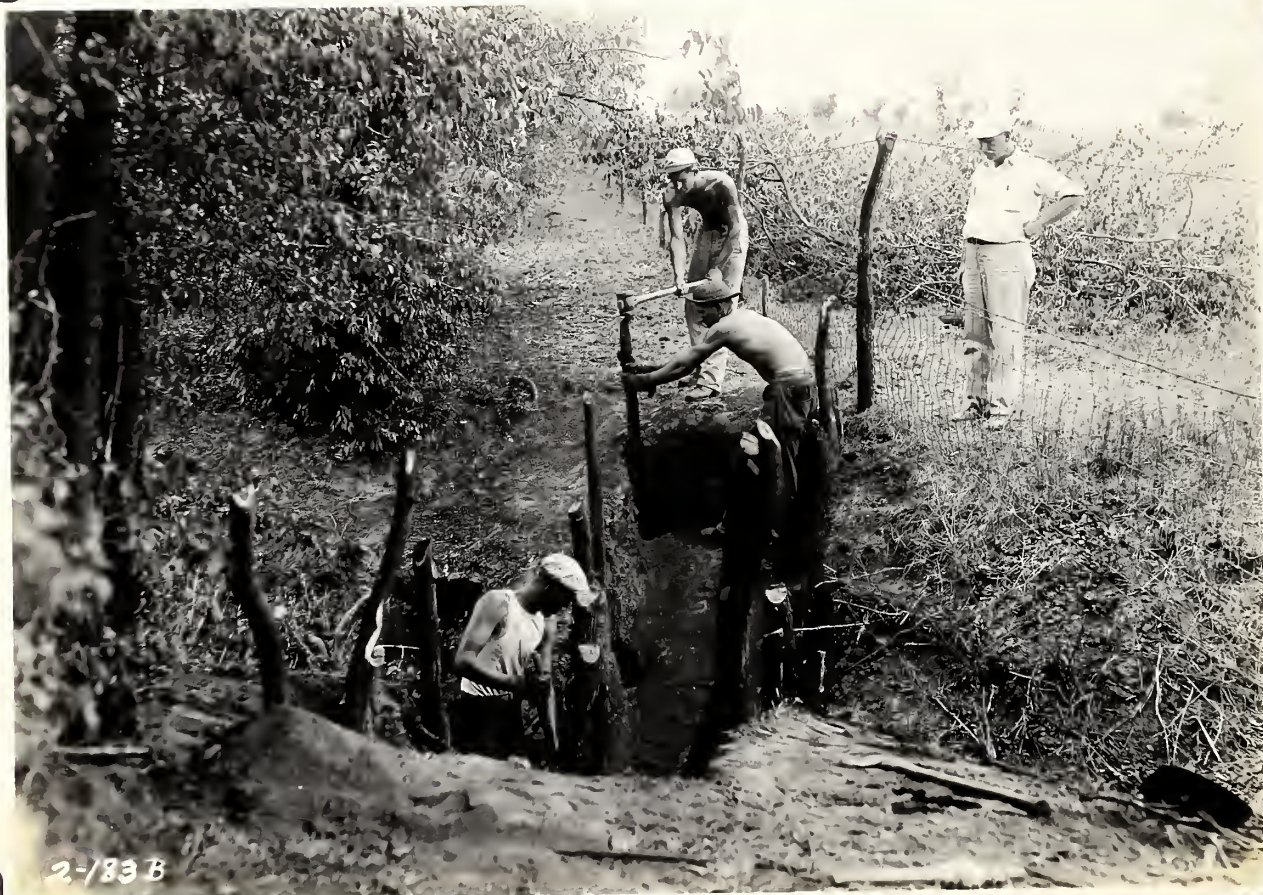
A double-post brush dam under construction.

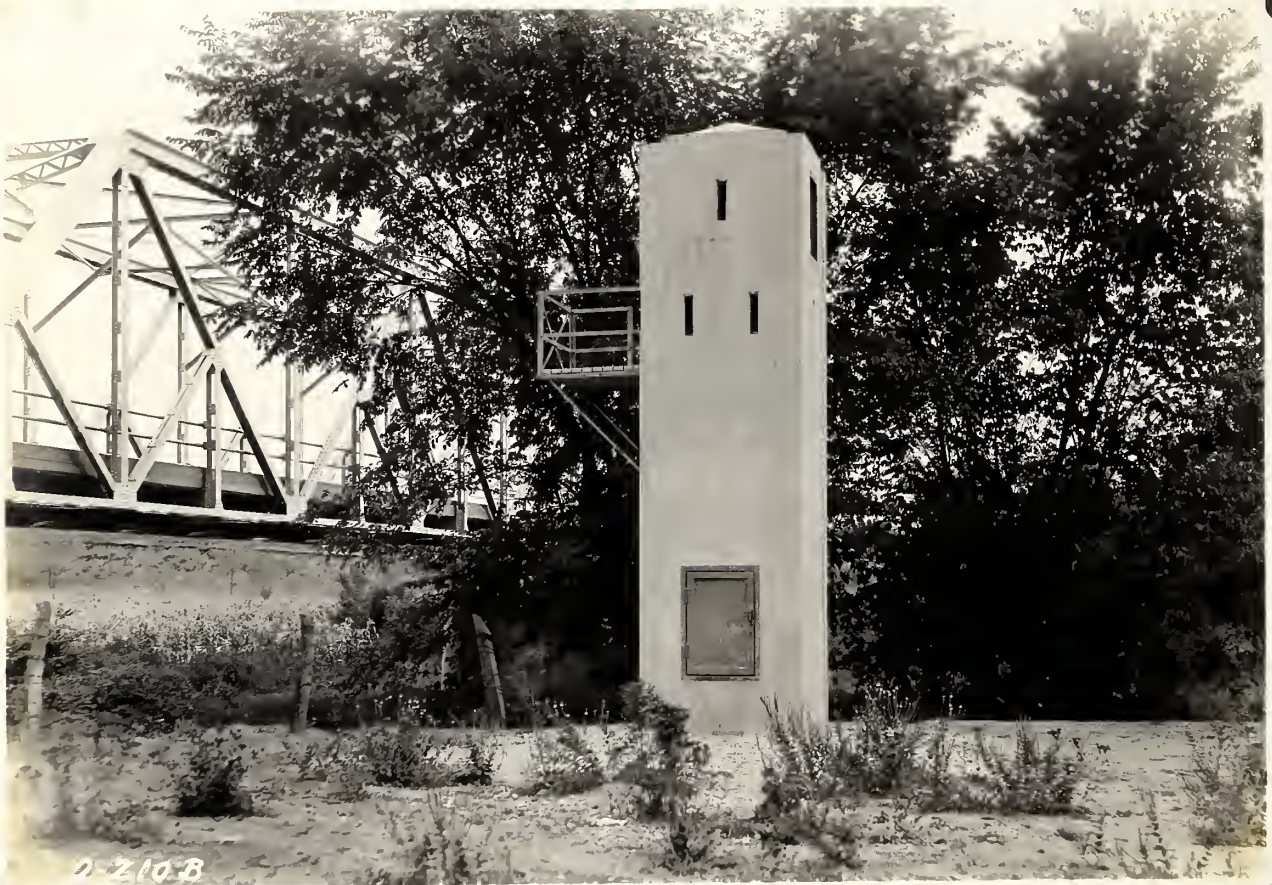
U. S. Geological Survey Gauging Stations measure the amount of water running out of East Big Creek Watershed and measure its silt content.
